Internal Service Bulletin for JLG Use Only ISB 10-20

<u>Release Date:</u>	July XX, 2010
<u>Subject:</u>	Elevation Switch Cover
<u>Product Type:</u>	Scissors
<u>Models Affected:</u>	ES Scissors
<u>Switch</u>	Rotary Angle Sensor
<u>Part Numbers Involved:</u>	1001092354 (Switch Assembly), 1001121241 (Service Kit)

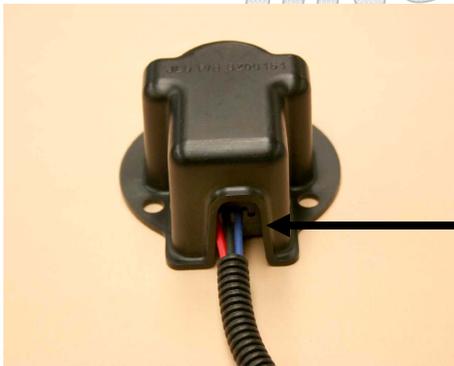
A change was made to the cover supplied on elevation rotary angle sensor (1001092354). The cutout width was increased to allow clearance for the wires to eliminate the rubbing condition which could result in the sensor not operating properly. Photos below show the affected part.

Original cover shows wires exiting off center of the cover causing the rubbing condition.

A service kit# 1001121241 has been created. This kit contains an updated cover (3200454) and the rotary angle sensor which needs to be used in place of the original. Any time a customer orders the original switch number he will receive the service kit in it's place. The customer should discard the original cover and replace it with the new cover.

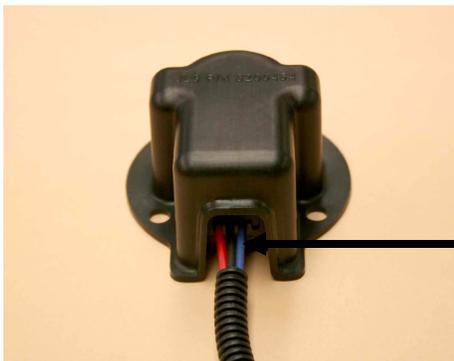
Modified cover shows wires centered exiting cover eliminating the rubbing condition.
