330/430/530 LRT Throttle Actuator Installation Guide

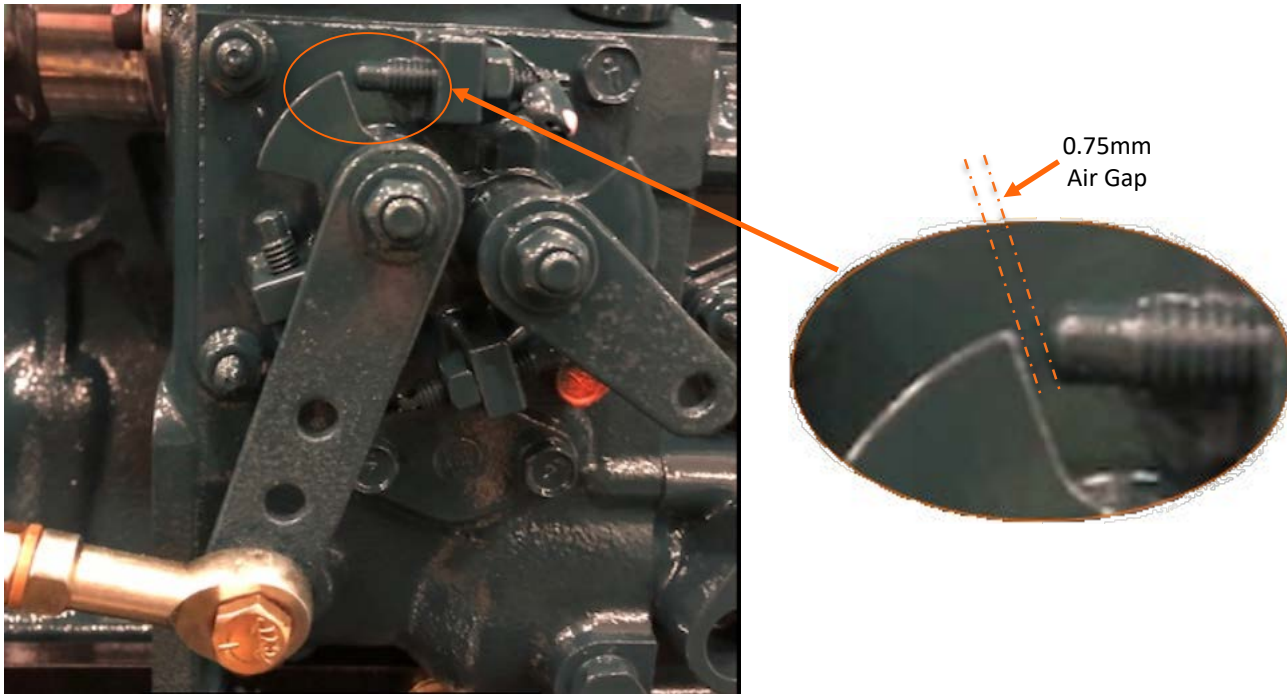
PROPER AIR GAP SETTING

- WHEN ACTUATOR SOLENOID IS ENERGIZED, PLUNGER MUST BE FULLY SEATED TO PREVENT COIL BURNOUT
 - 0.75mm gap must be present between the throttle arm and high idle stop which allows plunger to be properly seated

NOTE: IMAGE SHOWS ACTUATOR IN ENERGIZED STATE

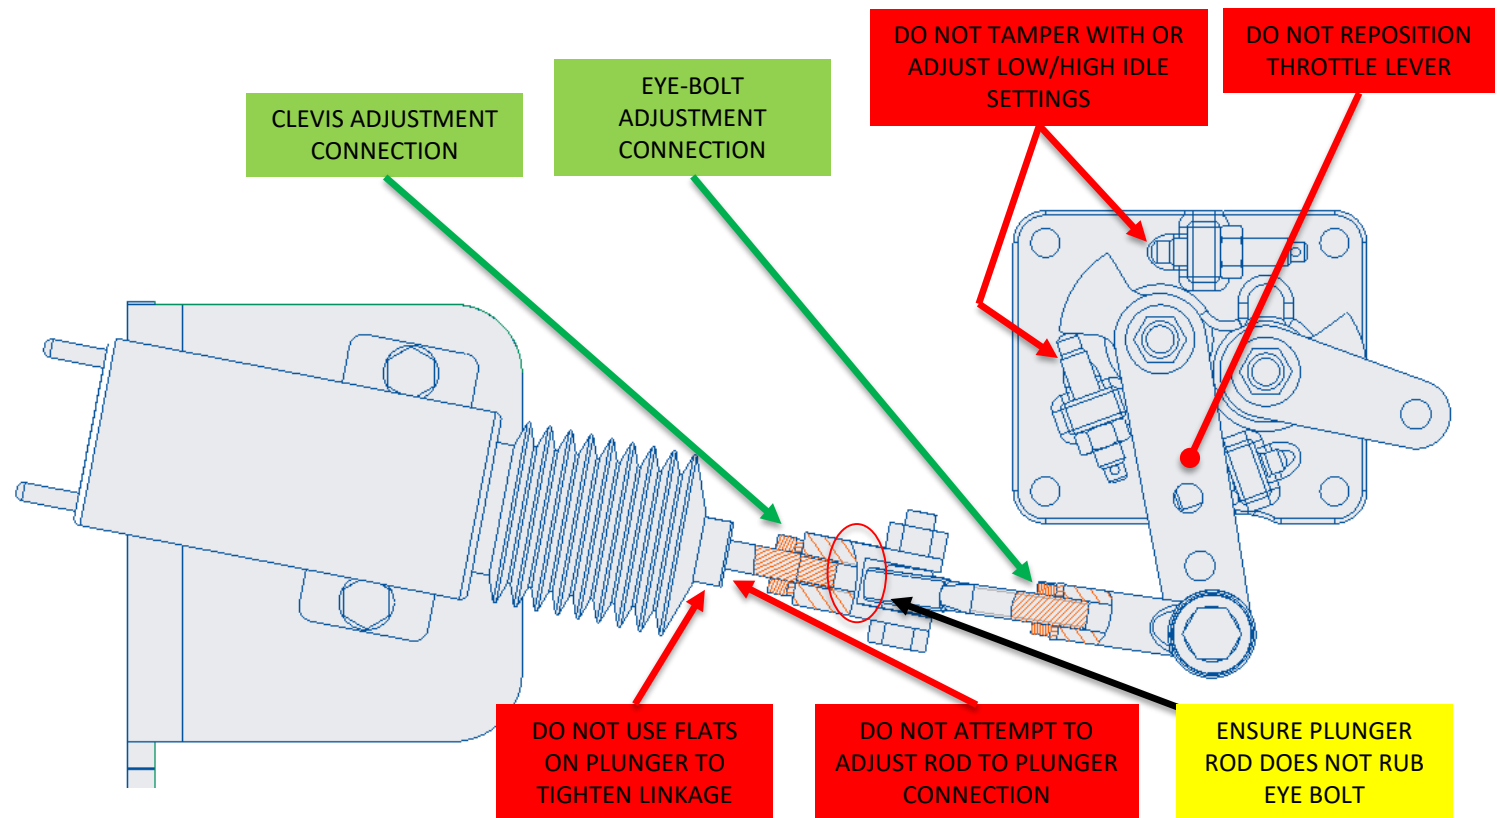
- ADJUSTMENT POINTS

- The hardware at the clevis and eye-bolt connections can both be adjusted as needed to maintain proper air gap

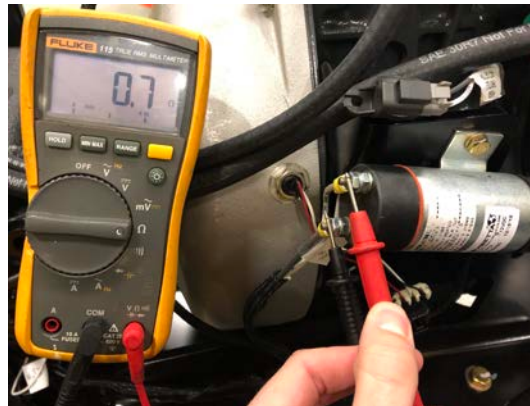
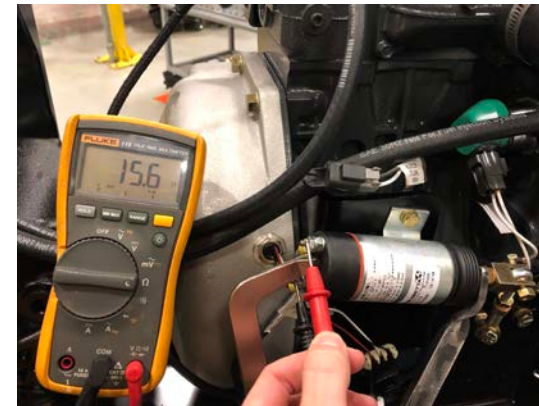
- MEASURE PLUNGER TRAVEL DISTANCE FROM ENERGIZED TO DE-ENERGIZED POSITIONS. TRAVEL SHOULD NOT EXCEED 1".
- VERIFY PLUNGER MOVES FREELY WITHOUT BINDING. IF BINDING OCCURS CHECK:
 - Plunger rod is not contacting eye bolt
 - Spacer is installed on correct side of lever arm
- USING A DIGITAL MULTIMETER ON THE BACK OF THE ACTUATOR, MEASURE THE FOLLOWING:
 1. Non-Energized State: 0 to 1 ohms
 2. Energized State: 14 to 17 ohms
